HMS VANGUARD 100

SURVEY 2016-2017

Survey Report

Emily Turton, David Crofts, Dr Clare Fitzsimmons, Prof Chris Rowland, Prof Kari Hyttinen, Simon Kay, Lt Jen Smith, Bob Anderson, Marjo Tynkkynen, Kieran Hatton, Dr Joanna Porter, Ben Wade

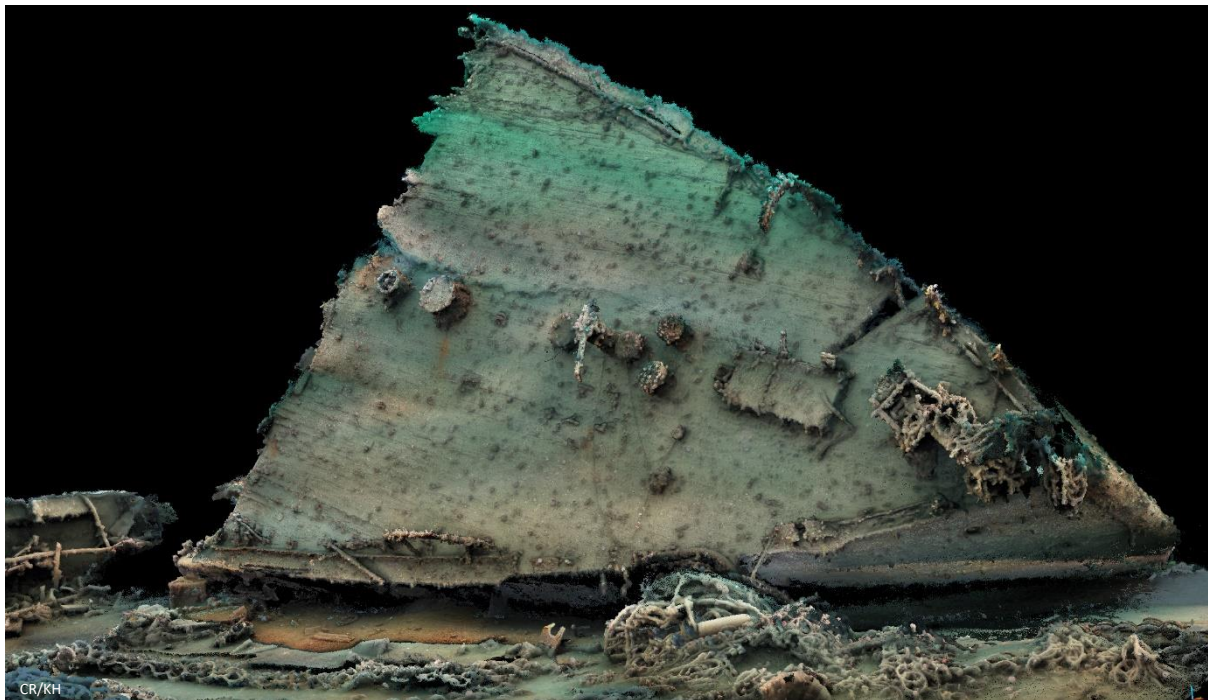
Figure 17: Dense point cloud showing the Stern section and torpedo nets on the seabed

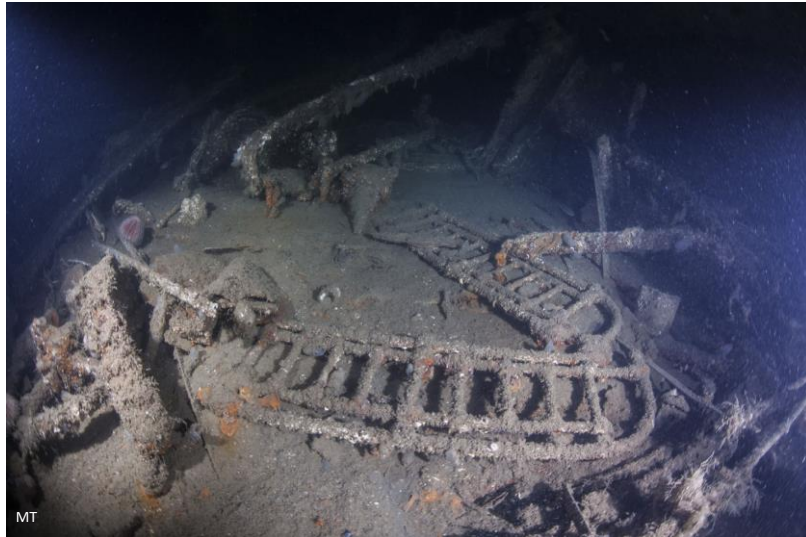
Figure 23: Officers bed frames

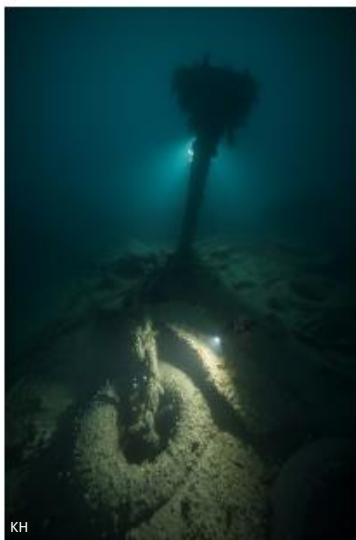
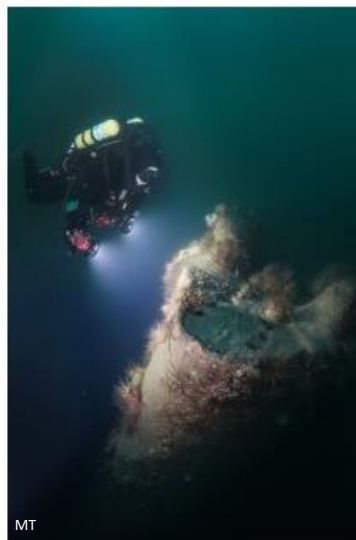
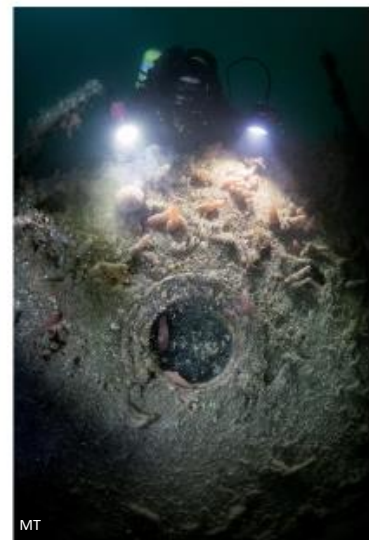
Figure 24: Main capstan protruding from the deck: the Bow; starboard side scuttle

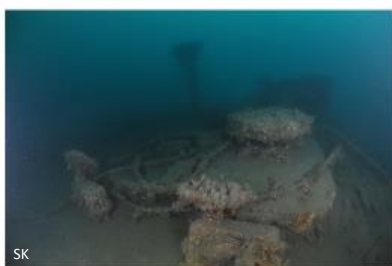
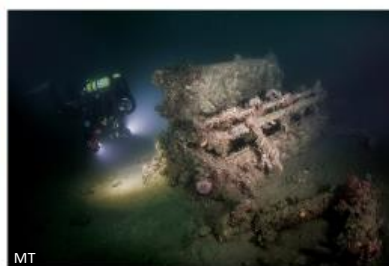
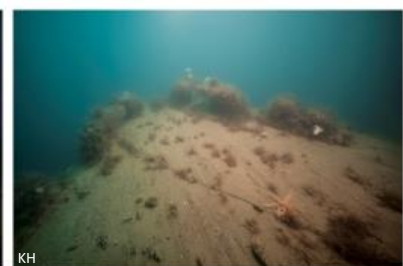
Figure 25: Intact cable holder, forward skylight, teak decking and fairleads

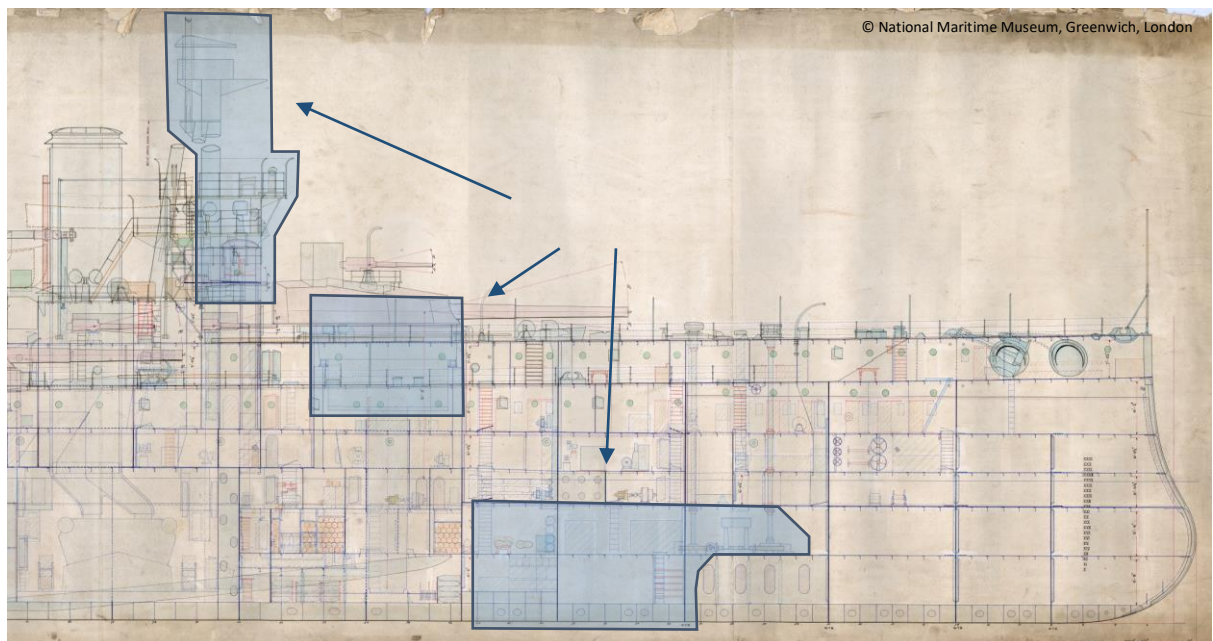
Figure 27: Extent of wreckage at A Turret and Bridge

This is a substantial collection of wreckage covering an area of approximately 40m by 15m. A 12-inch turret, almost certainly A Turret, rests on its side. Aft of this is wreckage from the bridge area including the foremast, spotting top, fore bridge and compass platform, signal and conning tower. The wreckage also includes capstan machinery from the Platform Deck (frames 26-30) and the substantial double bottom hull plating on which it was mounted, and the submerged torpedo tube doors from the forward hull sides at Platform Deck level (frames 41-43).

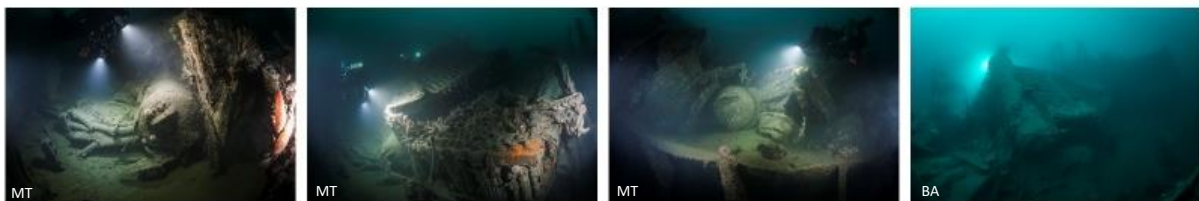
Eight boilers (survey numbers 1, 2, 3, 4, 5, 7, 8, 13) have been identified in this area, however, it is highly likely that more are buried beneath the visible boiler wreckage. Aft of the boilers and on the datum line is a circular ring structure likely to be deck structure for X Turret. X Turret is missing from this section and has been displaced towards the stern. To the west of the datum line is an area with a high concentration of 12-inch Clarkson cases. Four-inch propellant cases and 4-inch shells are also present. This is consistent with the X Turret Magazine and adjacent 4-inch Shell Room. To the east of the datum line is an area with multiple 12-inch shells, which appear to be 'stacked.' Based on location, this is highly likely to be the 12-inch Shell Room for X Turret (frames 139 to 148).

Figure 32: Babcock and Wilcox boilers

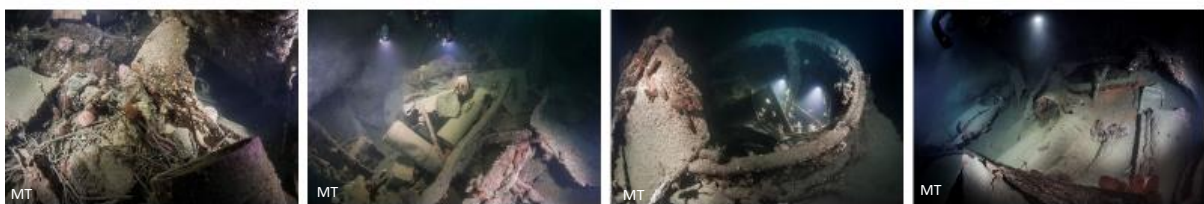
- A slight depression in the seabed of depth $\cong 1\text{m}$, absent of substantial pieces of wreckage.
- Randomly scattered sticks of cordite and small pieces of coal and shoe soles.
- 4-inch cordite cases heavily deformed and turned inside out by the effects of explosion, clearly identifiable by their corrugated case-form.
- 12-inch Clarkson cases empty of cordite, split open and with heat damage.

Figure 33: 4-inch shell & cordite; 12-inch Clarkson cases and 4-inch propellant cases; X Turret deck ring; X Turret 12-inch shell bin

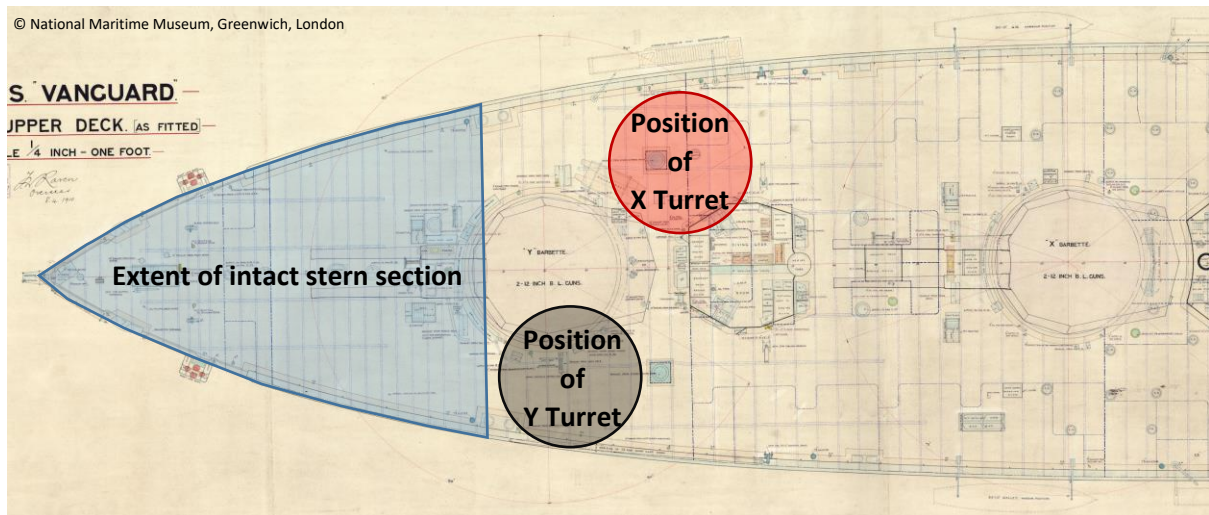
aperture at the “break” in the hull. This bent section of upper decking contains a distinctive curved edge, that is almost certainly the deck aperture for Y Turret barbette (frame 200). Adjacent to this, Y Turret sits upright on the seabed. The gun house and barrels are missing. On the seabed sits the only 12-inch barrel located during the survey. It shows signs of salvage – the barrel is broken and the base of the barrel is stuck in the seabed, but has salvage chains wrapped around it. X Turret sits 10m to the northwest from Y Turret. It is also upright with gun house and barrels missing. The turret has been displaced from its original position forward of the turbine rooms.

Figure 36: Position of X & Y Turrets in relation to the stern

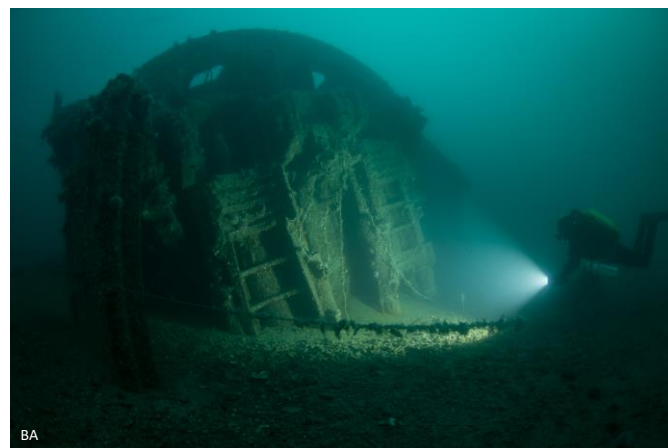
Figure 40: P Turret

P Turret is located on the seabed approximately 20m to the west of Boiler Room 3, approximately 35m south-southwest (aft-port) of its original position in the ship. P Turret lies on its side and some shield armour remains jutting out of the seabed.

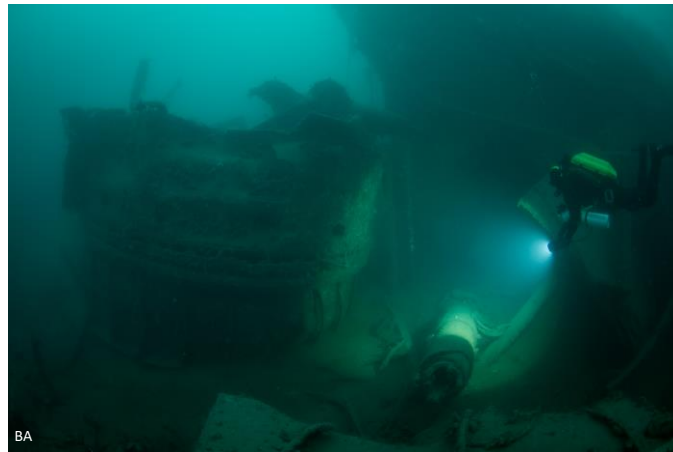
Figure 43: Y Turret & severed gun barrel

Y Turret is located in the Main Aft section. It is detached from the stern and lies upright immediately south of the Engine Rooms. It is in approximately the same position relative to surrounding wreckage as it was in the ship.

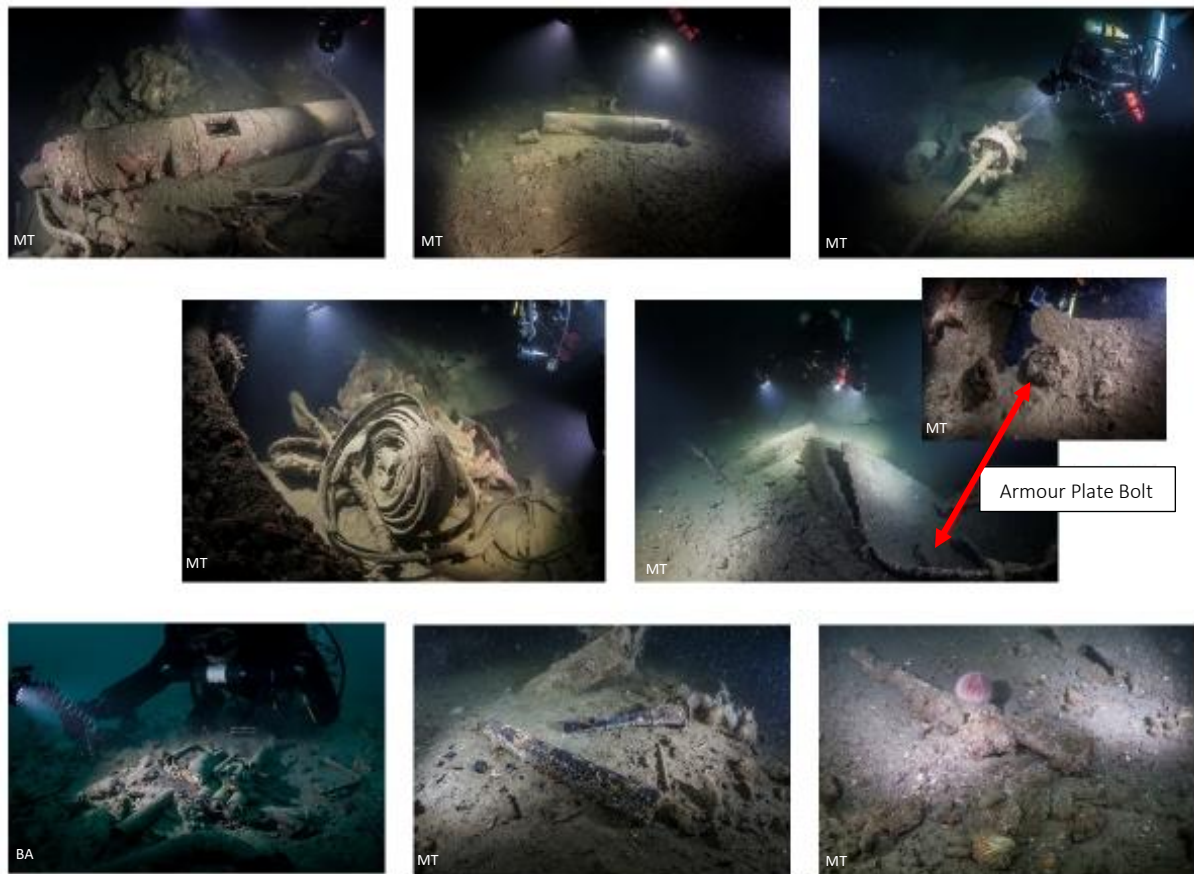
This area contains a very large section of wreckage, likely associated with the starboard hull between Q and X Turrets. The wreckage begins approximately 10m east of the datum line and extends a further 20m before bending at 90 degrees to the south for a further 30m. At the corner a section of 10-inch armour plating protrudes from the seabed. Evidence of coal bunker structures are present, including large amounts of coal. There is a 30.4m continuous section of bilge keel visible, providing evidence for this wreckage being hull section. Two

boilers (survey numbers 6, 11) are located here. Other features in this area include a range finder and a lay shaft from one of the engineers workshops. The remains of musical instruments were located on the seabed, specifically the body of an oboe and clarinet and the remains of a brass instrument, probably a euphonium given the size of the valve block. A rifle lies in the vicinity of the musical instruments.

Figure 45: Top: two sections of range finder; lay shaft. Middle: coil of hose; armour plate with armour bolt inset. Bottom: brass instrument; woodwind instruments; rifle

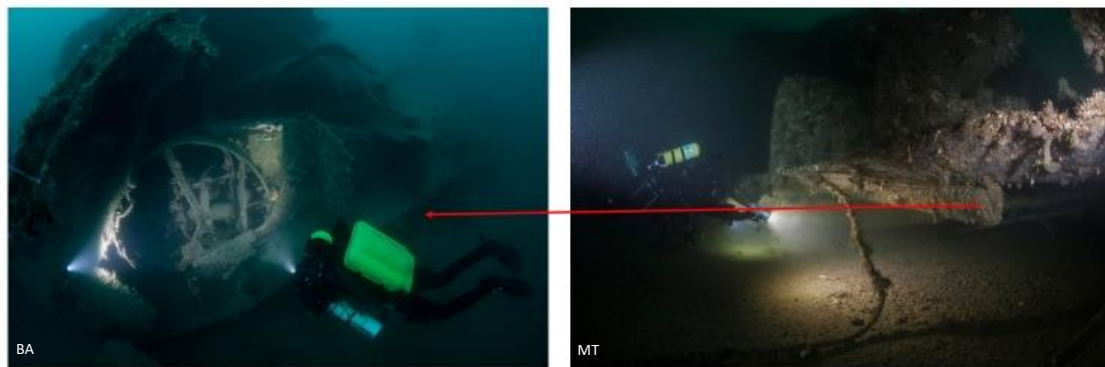
Figure 49: Debris 5: gun barrel visible under wreckage

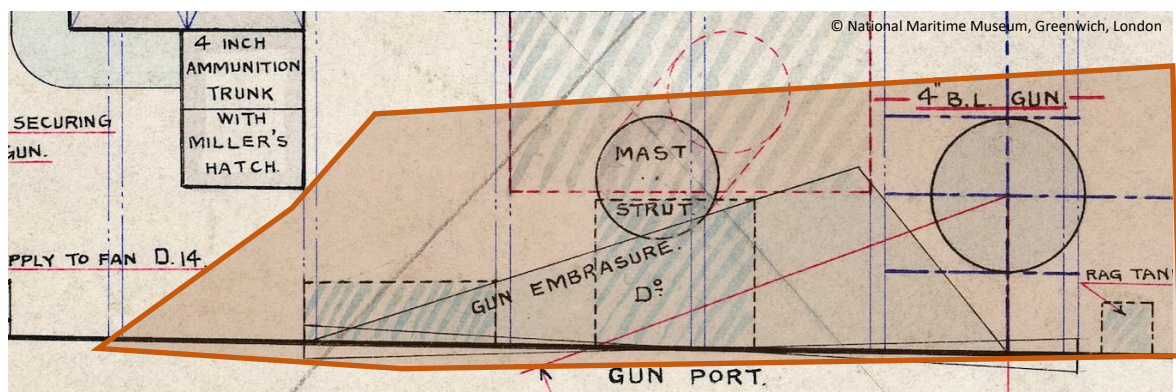
An isolated section of aft starboard side superstructure, including a 4-inch gun mount and embrasure and the base of the starboard main mast strut.

Figure 51: Debris 1

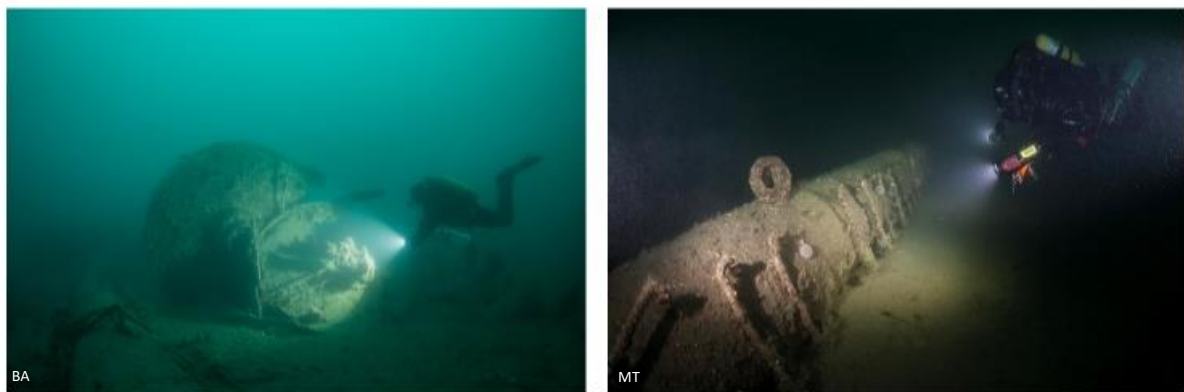
Three distinct pieces of the main mast lie on the seabed some 72 metres aft of the stern. The external ladder is visible on the north-most section. Spotting top platforms and part of a rangefinder were located on the other sections.

Visible are the remains of the uppermost platform and a short section of the main leg and approximately 10m of one of the mast struts, side unknown. The remainder of the main mast and struts are missing and were not located on the wreck site.

Figure 52: Main mast section and spotting top

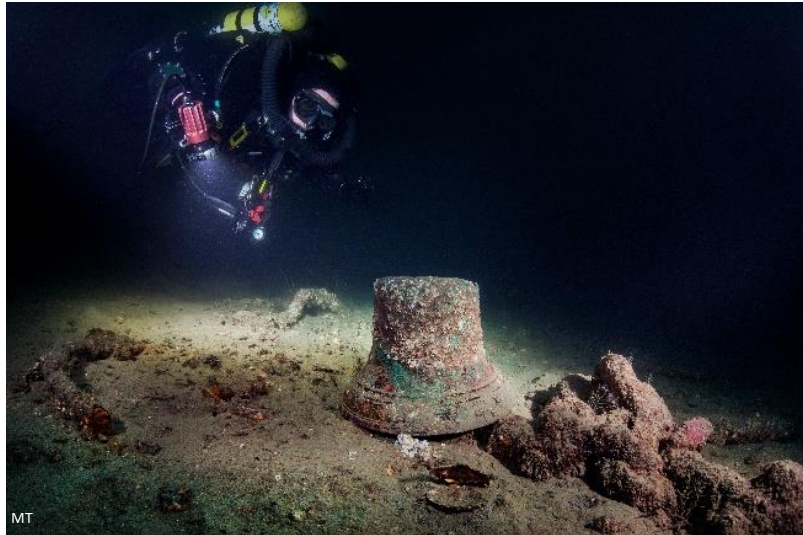
Isolated and lying some 180 metres from the main wreck site and 60 metres from the aft superstructure is a ship's bell, presumed to be the aft bell from VANGUARD. No lettering was visible. There is damage to the top of the bell consistent with an explosion. The distinctive end of the ship's main boom with associated lifting tackle lies some 10m from the bell.

Figure 54: Ship's bell

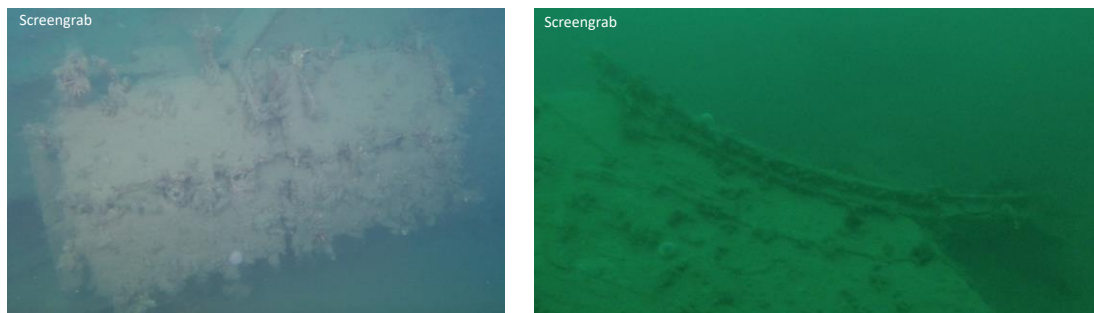
Debris 2 consists of a large piece of starboard side decking lying over the top of a smaller piece of decking. The larger piece contains a four-paned skylight adjacent to a small square vent which pinpoints this to the sick bay. Only two four-paned skylights are found on the ship's plans. The first is in the bow above the Gun Room, which is still in situ, and the second above the Sick Bay towards the stern on the starboard side. Also present is part of the curved deck aperture for X Turret. The smaller decking underneath is a piece of side decking with spurn water still intact. Brackets for stanchions, a small deck cleat and a scupper are all visible.

Figure 55: Debris 2: Sick Bay skylight and X Turret deck aperture

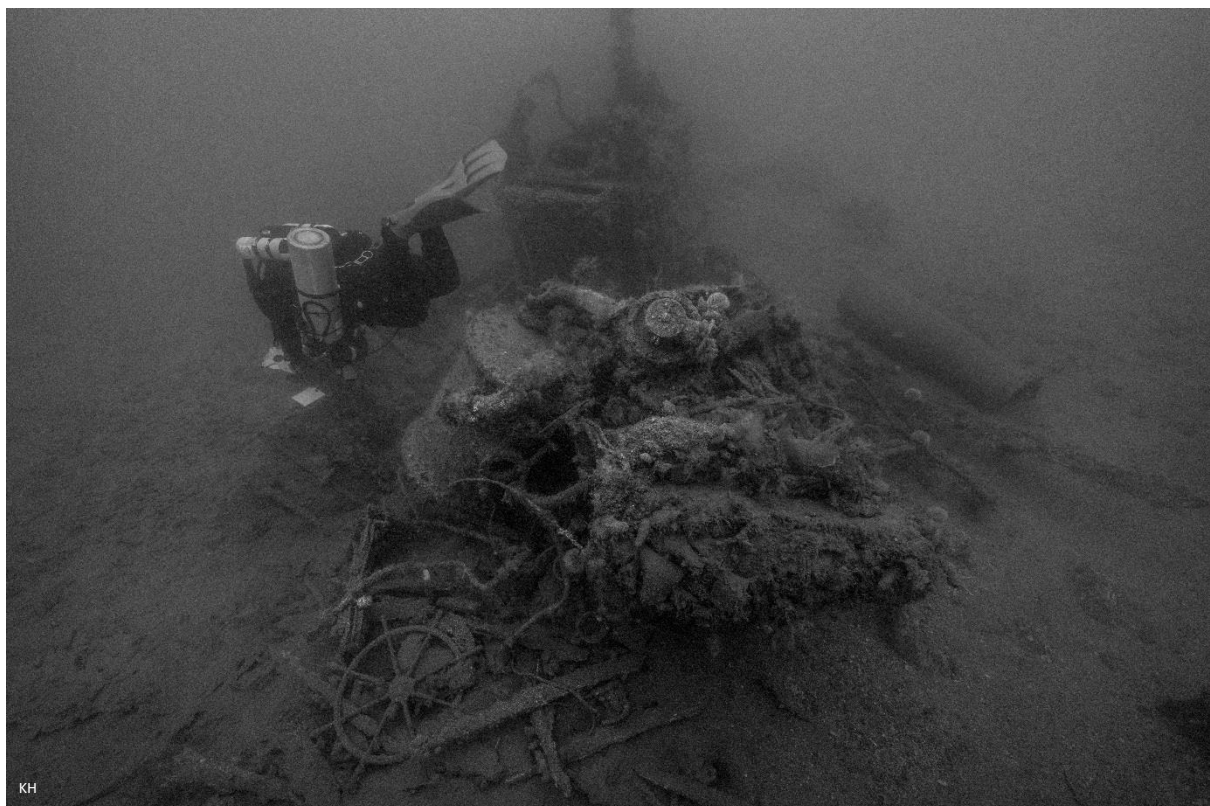
Figure 74: Steam Pinnacle 248 - HMS VANGUARD

While exploring scattered debris in the vicinity of the main mast (see Figure 52), hull sections of characteristic lattice wood construction were observed, and a small vessel located to the south of the main VANGUARD site. A nameplate later connected her directly with that vessel, and confirmed the find as Pinnacle 248. A basic survey of the area was undertaken, and key measurements recorded. A photogrammetric map of the small site was produced, using a GoPro Hero 4 and two 3XML Light-For-Me Video Lights, 3600 lumens each.

Divers found a site with low lying debris along most of the ~20m extent, but with areas of significant wreckage standing up to 2m proud of the seabed. From the basic sidescan available, remains appear to be oriented northwest (rudder) to southeast (bow).

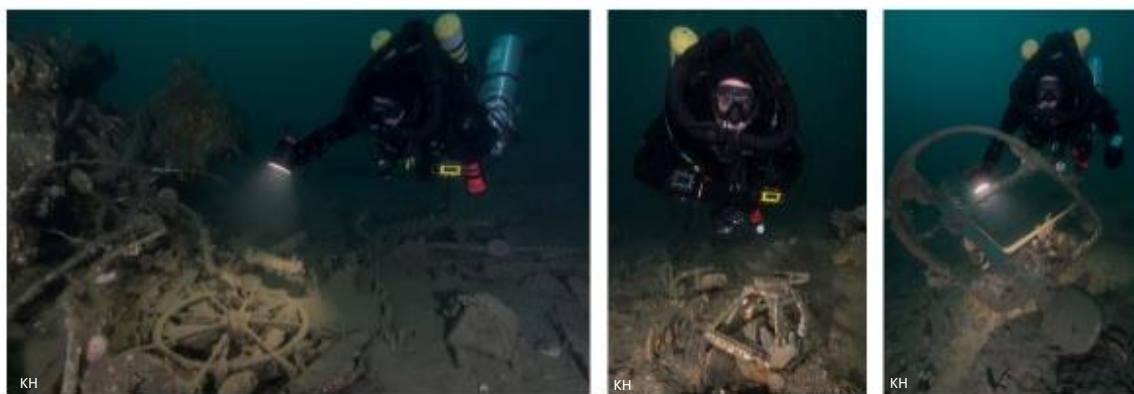
Figure 75: Pinnacle steering helm, Dent's boat compass and rudder

The central section is the most intact with helm and bridge fittings (including Dent's boat compass) still in situ. Moving forward, the steel engine and boiler stand clearly proud of the seabed, details like pressure and sight gauges still intact and in their original positions. Pipes and valves are evident aft of the boiler. The brass funnel sits off the wreck to the starboard side between the two. Moving towards the bow small bullets can be found, but the guns were not in position.

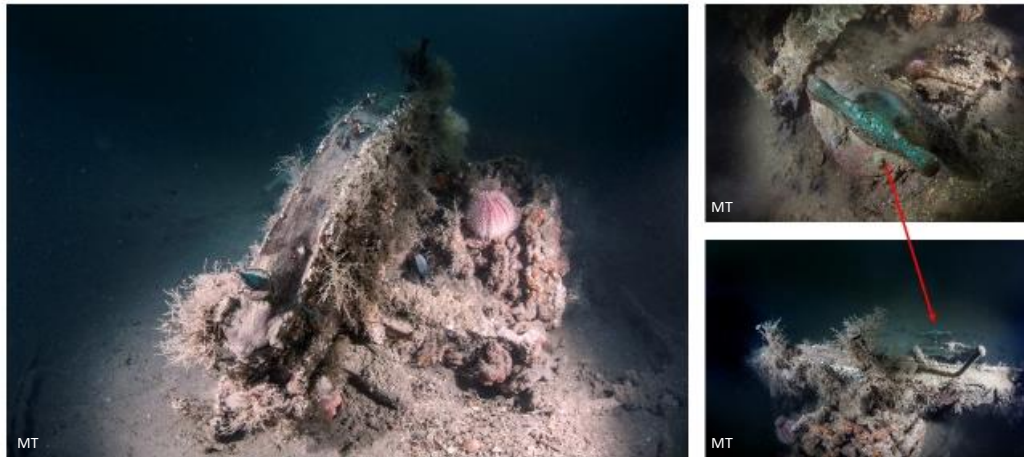
Figure 76: Wooden bow post with bronze bolts and a deck cleat

Further sections of latticed hull finally terminate in bow plating complete with cleats; chain locker and anchor; and the keel itself, original bronze bolts evident (Figure 76).

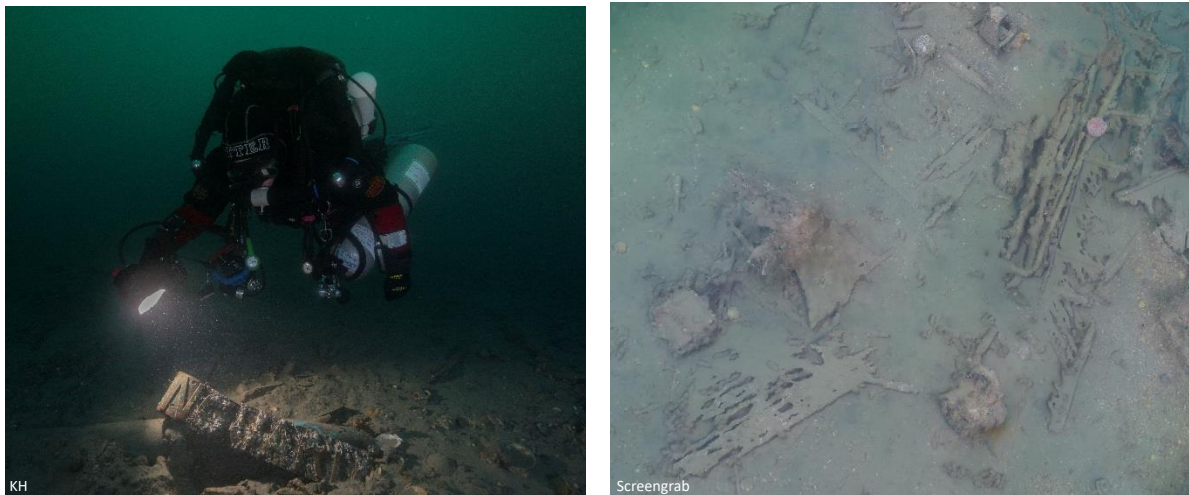
Figure 77: Nameplate and lattice frame hull

Swimming south from the main VANGUARD site the rudder is first encountered, its brass frame upside down on the seabed, all outer materials having been destroyed in the intervening years. The nameplate was found in this area. Barren seabed (possibly disturbed by fishing gear) is soon followed by sections of wooden hull, rib remains and planking, and frames of varying size scattered on the surrounding seabed. Some of the frames contain copper pins, and abundant large fragments of latticed wood provide evidence of the characteristic pinnacle double hull design, diagonal inner sheets combined with fore and aft outer sheets.

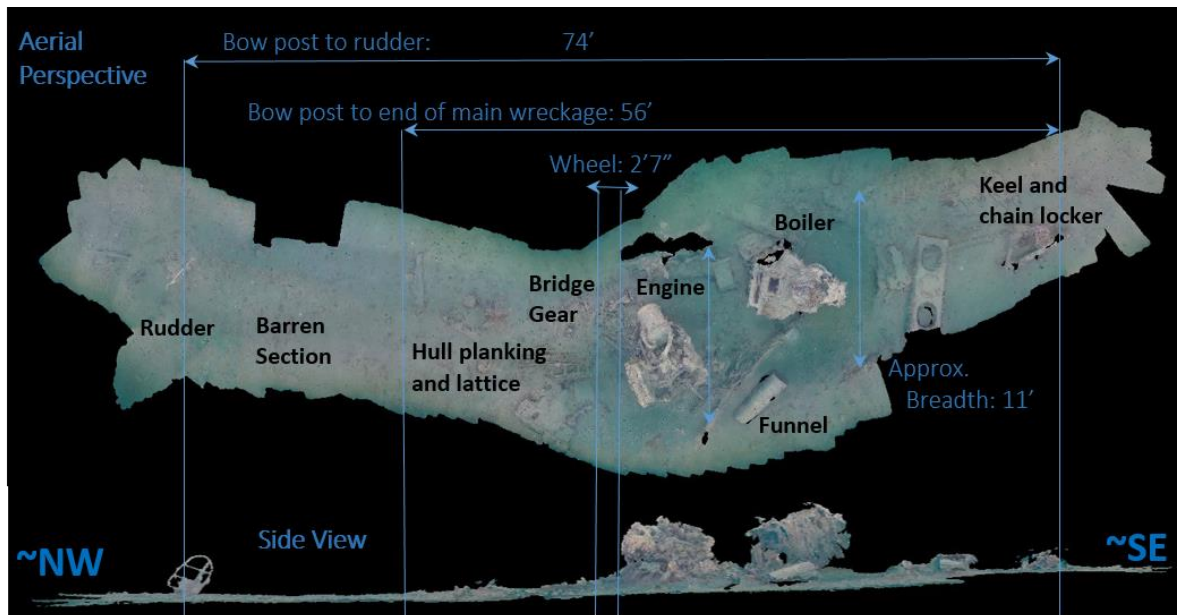
Figure 78: Basic survey measurements of Pinnacle 248 site visualised over aerial and side views of the site, created using structure from motion photogrammetric techniques (Fitzsimmons/Wade).

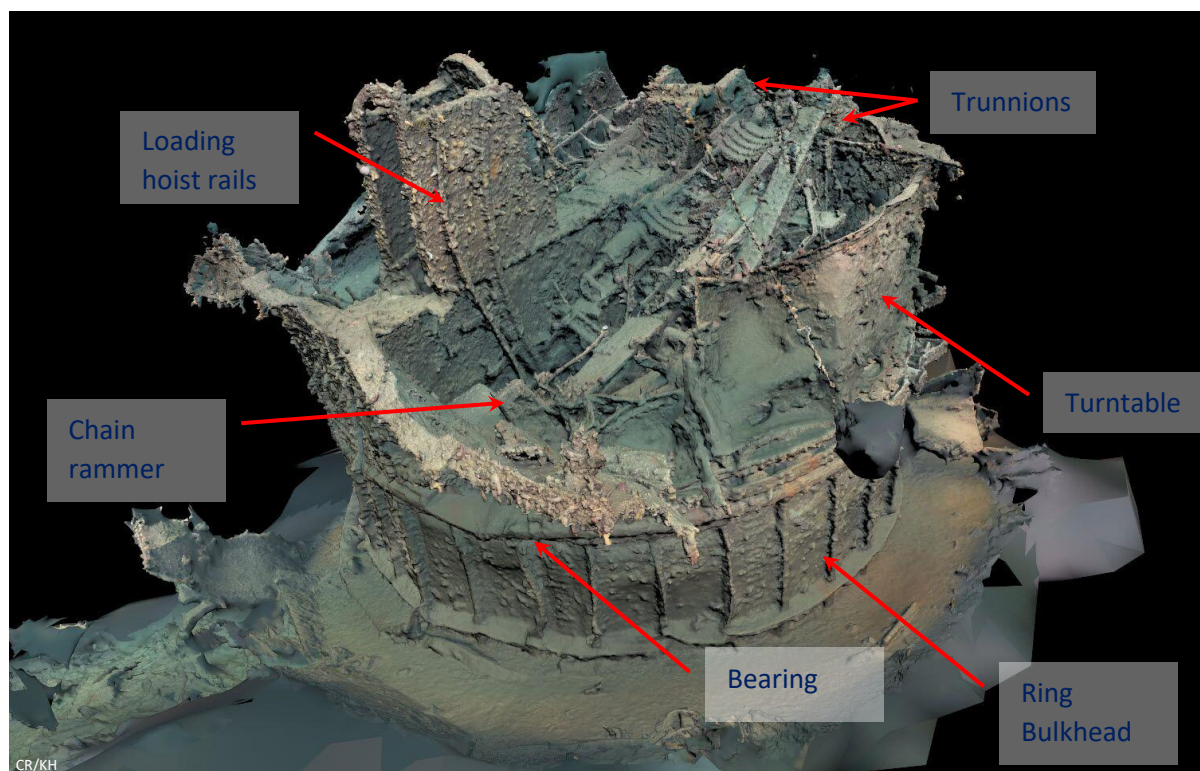
Figure 94: X Turret 3D photogrammetric model

X Turret is in the best condition of the five turrets and lies upright on the seabed, approximately 10m to the west of Y Turret in the Main Wreck Site. X Turret lies approximately 25m south-southwest (port-aft) of its original position in the ship.

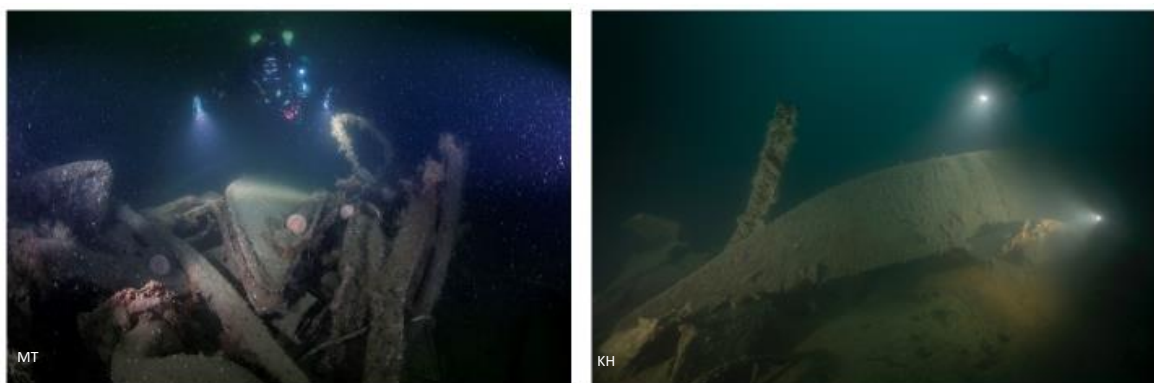
Figure 104: Port and starboard forward bilge keep ends

The fore and aft ends of the two bilge keels had a distinct tapering shape and were attached to the hull sides at Platform Deck level adjacent to A Magazine at the bow (frame 32) and Y Magazine at the stern (frame 128). All four bilge keel ends are now lying in the main wreck site with the two forward bilge keel ends lying at the northern (forward) end of the Main Hull Section, in the wreckage on the southern perimeter of the Forward Wreck site “gap.” They are approximately 25m apart in an east-west direction, and approximately 35m south-southeast (aft) of their original position in the ship.

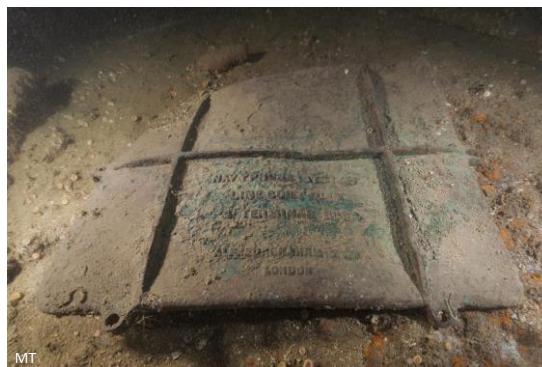
Figure 106: Navyphone Plate

There is a cast brass "Navyphone" cover-plate on wreckage to the northeast of the Main Hull section, close to one of the bilge keels and Q Turret ammunition hoist tube. In VANGUARD, the Navyphone switchboard was located in the telephone exchange on the Lower Deck starboard side, directly above A Magazine and adjacent to the Forward Fire Control Transmission Room and the Starboard Hydraulic Room. The plate is now approximately 50m to the southeast (aft-starboard) of its original position in the ship.

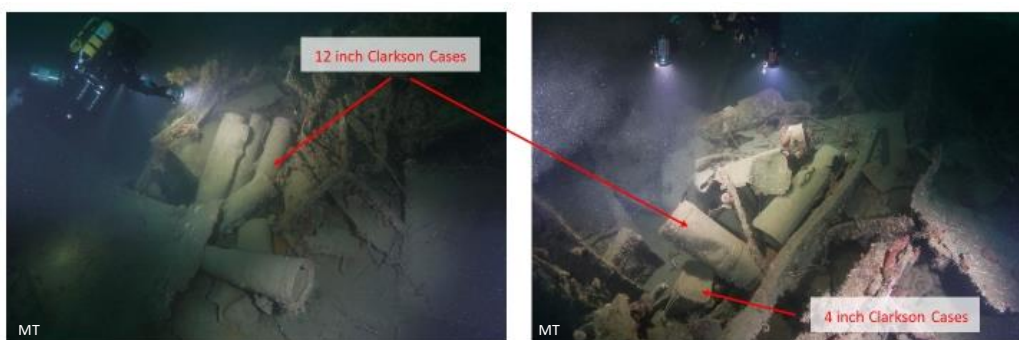
Figure 107: Clarkson cases

In the area of X Magazine port side there is a small quantity of empty and open brass Clarkson cases for 12-inch cordite charges, closed brass Clarkson cases for 4-inch cordite charges, and sticks of cordite littering the wreckage.

- x. The presence of 4-inch cordite cases that have been heavily deformed and turned inside out by the effects of explosion, and split and heat damaged 12-inch Clarkson cases lying on the seabed in the Forward Wreck Site "gap," suggests that both MD45 (12in) and MD16 (4in) cordite exploded in the magazines.

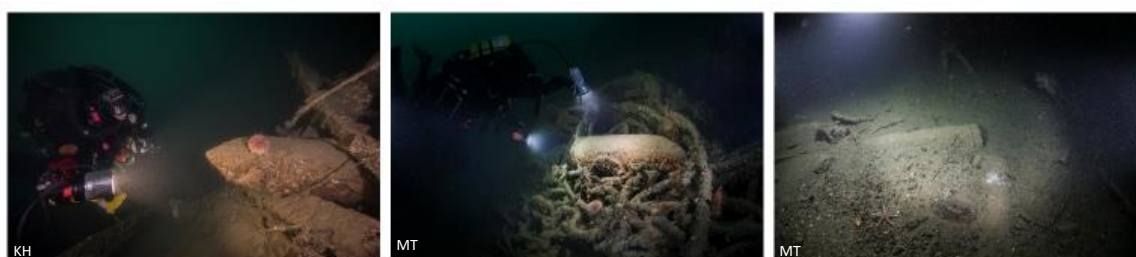
Figure 108: 12-inch shells

12-inch shells/projectiles are present at many locations on the wreck of VANGUARD, particularly to the east of X Magazine, beneath the stern nameplate, and on the seabed in the Forward Wreck Site “gap.” No evidence of shrapnel damage from detonation of shells has been observed.

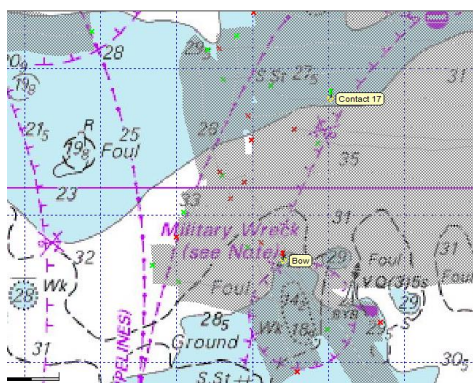
Figure 109: Chart extract showing Contact 17 in relation the the bow of HMS VANGUARD

A significant piece of wreckage exhibiting damage consistent with the effects of an explosion was located some 605m north of the main wreckage. It has not been possible to positively identify this wreckage as being from VANGUARD, however its damage and position are consistent with it having been projected from the forward part of the ship close to the exploding magazine(s). A positive identification of it would significantly add to the body of evidence relating to the location of the explosion in the ship.
